Root Cause Investigation by Furukawa

Wobbling of the sensor in EPS Column

13/May/2004 Furukawa Electric Co.,Ltd.

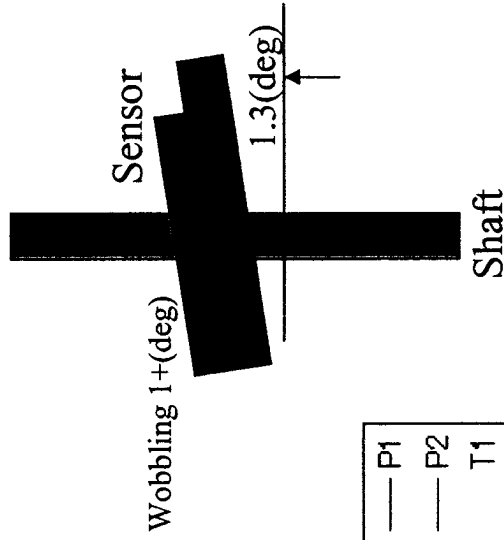
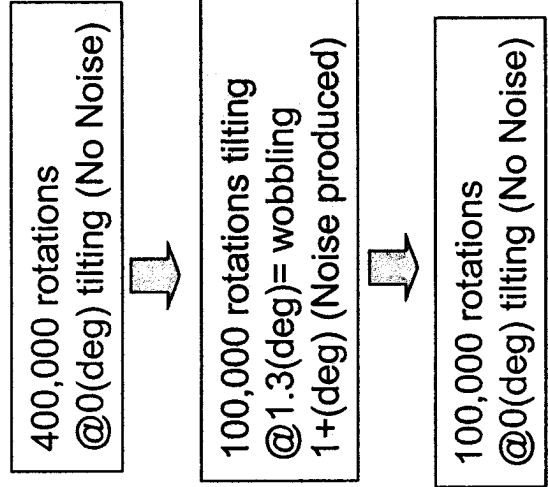
2-3 Spin test with competitor's sensor. (Fig 10)

Just reference: extreme stress test

This test not simulating actual vehicle condition.

When we performed Spin test using competitor's sensor at FEC, significant signal noise was detected when the sensor was tilted at 1.3 degrees from the shaft. After changing the tilting angle to 0 degrees the noise disappeared. But the robustness of competitor's sensor is higher than FEC's. Probability of noise creation may be much lower than FEC's.

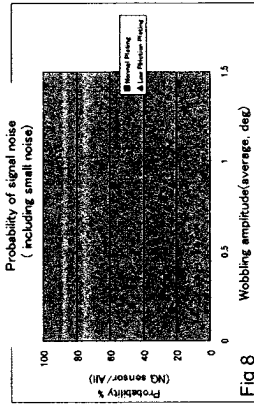
When the sensor is wobbling, the wires move side ways, and produce a stick slip motion.

Side ways motion can easily cause the stick slip of all wires resulting in an unstable contacting condition.

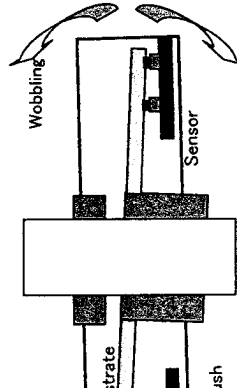
Competitor's sensor also produces signal noise when the brushes slip out of the sliding track. (reference)

This is extreme stress test

This test not is simulating actual vehicle
